METALLOCK FRACTURE REPAIRS GIVE LISTED BRIDGE NEW LEASE OF LIFE

When you have a Grade II Star listed cast iron bridge that develops fractures that need to be invisibly repaired, do you dismantle it and send it away or call in the experts to restore it in-situ. That was the predicament that the bridge department of Staffordshire County Council found themselves in with the Chetwynd Bridge over the River Tame on the A513 at Alrewas.

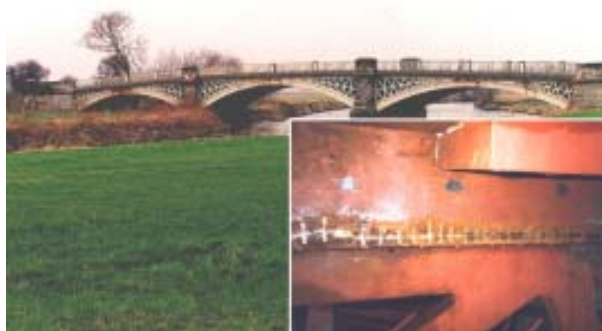
The cast iron bridge, constructed in 1824, has three spans with a series of box sections, forming the outstand, supported on the cast iron girder structure. A combination of age, water ingress into some of the box sections and vibration caused a series of fractures to develop just above the lower corner joint. These extended nearly all the way along one side of the bridge and also for a considerable distance along the opposite side. Following an assessment of the problem by Metallock engineers, it was decided that the metal stitching technique, carried out in-situ, would provide an effective and long lasting repair without dismantling the bridge.

Before Metallock repaired the 177-year old Chetwynd bridge over the River Tame there were serious cracks in the box sections along the two sides. Metallock cured the problem and the bridge lives on.

The Metallock process is accepted as a method of repairing cracked and broken castings across a wide range of industries. One of the main advantages of the process is that it is heat free and can be carried out in-situ or one of the company's workshops. Apertures are jig drilled across the crack to accept multi-dumbbell shaped keys manufactured from a ductile high tensile nickel alloy. The keys are peened into the apertures to become integral with the parent metal. Holes are then drilled and tapped along the line of the fracture and filled with studs, each one positioned to overlap its neighbour. This combination of keys and studs produces a rigid and pressure tight repair and final peening and hand dressing completes the operation. Once the repair has been dressed, a primer applied and finish painted it is practically undetectable.

For the Chetwynd Bridge, the team of four Metallock engineers spent 3 fairly severe winter months completing nearly 74 metres of fracture repairs. Additionally, the team carried out similar repairs to some strengthening ribs underneath the main deck, where other fractures had developed.
