Press Information

METALLOCK REPAIR GIVES KILN MAIN DRIVE GIRTH GEAR NEW LEASE OF LIFE

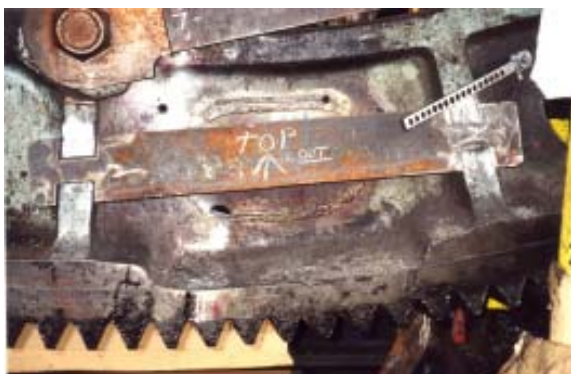
The 6.5 metre diameter cast steel gear developed cracks emanating from four of the oval windows between spokes. As well as metal stitching plates into the windows, Metallock stitched tie plates across the ovals to provide extra strength

After examining the gear, Metallock engineers decided that a possible solution would be to remove the welded inserts and fit new ones with tails top, bottom, left and right and secure them with metal stitching.

As well as the window stitching operation Metallock devised a system to stitch a tie plate located in cut-outs in the ribs either side of the repaired window to provide some additional strength. A tie plate was also applied across the remaining welded insert to provide support while Metallock were off site between stitching repairs. Over 12 months has passed since the last repair and the gear has shown no further signs of cracking which is evidence that the Metallock process is suitable for repairing cast steel as well as cast iron components.
