Press Information

ON-SITE MACHINING AND FLAKE GLASS COATING REPAIR RESTORES VERTICAL PUMP OFFSHORE FOR MARATHON OIL

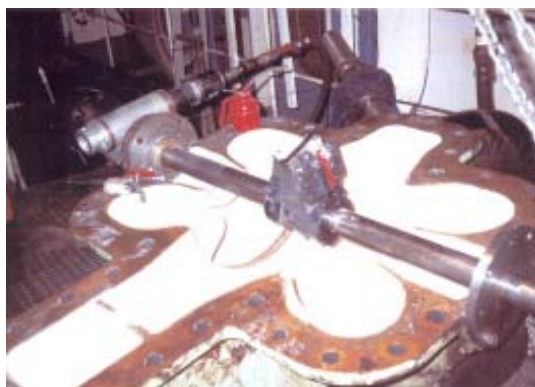
Metallock Engineering has recently restored a vertical pump - used for the transfer of sweet crude on a Marathon Oil floating storage and offloading (FSO) vessel operating off the West Coast of Africa – to full working condition. The pump had sprung a leak, and on investigation, it was found that due to a loosened locknut the impeller had dropped, causing considerable damage to the volute form of the casing and the lower gland seal area of the pump.

The Metallock repair, carried out offshore, involved the application of a flake glass coating material followed by machining using line boring techniques to recut wear ring glands.

Metallock was called upon to investigate whether a repair was possible. Once the pump had been dismantled, the extent of the damage was assessed and a decision taken that a successful repair could be effected. The repair would involve the application of a specialist flake glass-filled coating material. Before this could be done, damaged wear ring lands and internal areas of the pump casing had to be machined, and the entire internal surface shot blasted to ensure a positive bond between the bronze pump body and the glass flake filled coating.

The blasting and coating work to the internal surface area of the pump was carried out for Metallock by UK corrosion engineering specialists Corrocoat, using experienced personnel from the organisation's application facilities in South Africa. The coating system selected was from the company's own Corroglass 600 range, comprising a vinyl ester base loaded with glass flake. For this application, the product was brush applied in coats to build up the excessively worn surfaces, curing swiftly to offer high levels of chemical resistance in use. Once the new lining and restored areas were completely cured, Metallock dressed the joint faces of the two halves of pump casing before setting up a boring machine in the bottom half casing to recut the wear ring lands. The two halves were then bolted and dowelled together, and the relevant areas machined using appropriate Metallock on-site line boring equipment. On completion the casing top half was removed and all dimensions inspected prior to fitting new bearings and a replacement impeller.
