Press Information

METALLOCK USES ITS METALLOCKING EXPERTISE FOR DUBLIN'S HA'PENNY BRIDGE RESTORATION

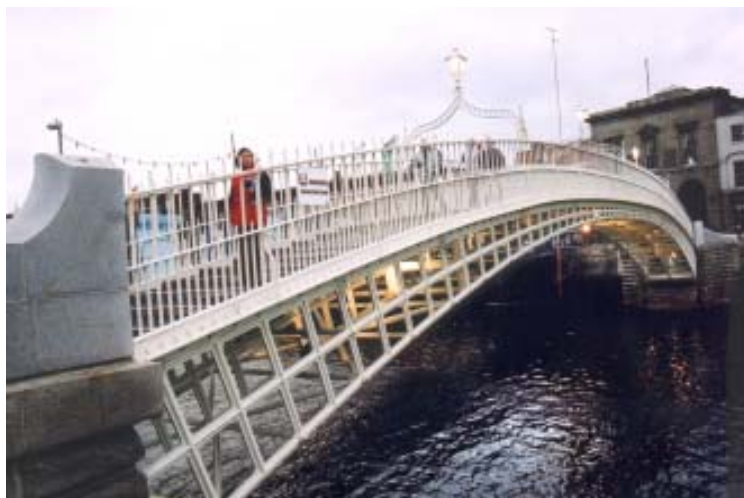
Most of Metallock's work involved tie-rod end caps, 43 of which had cracks and were repaired, and cracked diaphragm rib plates. Additionally, Metallocking was used to repair construction webs and install new corbel sections to replace those that had broken off over the years. Most of the damage to the components that needed repair had been caused by expansion due to corrosion from moisture ingress following the breakdown of joint sealing materials.

Most of Metallock's work involved tie rod end caps, 43 of which had cracks which were repaired and cracked diaphragm rib plates.
