Press Information

METALLOCK CLAIMS THE FIRST SUCCESSFUL BEARING POCKET TRANSPLANT IN ALUMINIUM ALLOY GEARBOX CASING

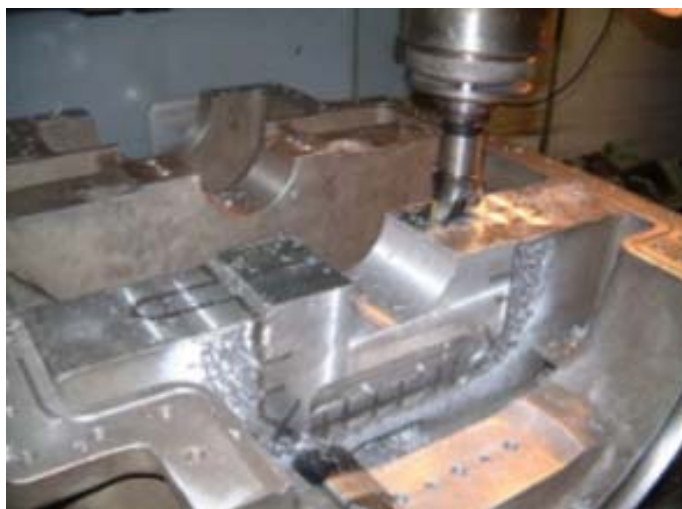
On completion of the Metallock repair, the bore, journal pocket sidewall and joint face were machined to the customer's specification.

The casing was transferred to Metallock's well equipped Coventry workshops and a template made enabling a new insert to be manufactured by machining from a solid block of similar material. The area to be removed was marked out and the casing machined to the predetermined dimensions. As well as the area to accept the main body of the insert, slots were machined into either side of the joint face to accept lugs on the insert which add strength and aid location. Once the insert was machined it was placed into the pre machined aperture in the casing. The casing was now ready for repair by Metallocking.

To secure the new insert Metallock used over 100 dumbbell shaped keys and nearly 200 Metaloy screw studs over almost 1¼ metres of joint interface. On completion of the repair, the bore and journal pocket sidewall and the joint face were machined to the customer's specification. The casing was taken back to Allen Gears and the whole process from delivery at Coventry to completion had taken less than fifteen days. The gearbox was subsequently built, put into service and has operated trouble free for over 10 months.
