METALLOCK OVERCOMES CORUS BOS VESSEL DRIVE BACKLASH PROBLEM

Having a 1500 tonne BOS vessel that is rocking more than it should do when being tilted can cause problems, but how do you overcome it? Such was the situation at Corus, Scunthorpe with the No 1 vessel when it was discovered that the four keyways on the trunnion diameter linking to the drive bull wheel were badly worn.

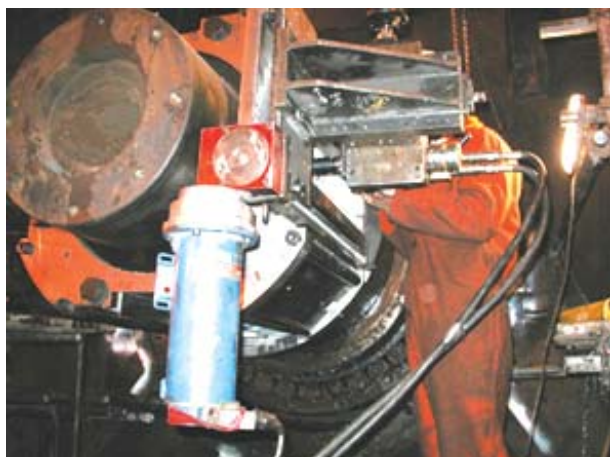
The in-situ machining was very accurate and better than machining the hub in a workshop.

It was decided that things would be left as they were until the next change of bearings was scheduled during a plant shutdown. At this time, when everything was dismantled, a team of Metallock engineers moved in to machine the keyways to clean up. Using their own specially designed tooling, Metallock proceeded to machine 1mm from each face and the bottom from each of the four keyways equi-spaced on the 1054mm trunnion diameter. The keyways were 215mm wide, 686mm long and 81mm deep.

The tooling comprised an inner ring and spacer legs loaded to the shaft at the vessel end. A front plate located on the shaft diameter and was bolted to the shaft and spacer legs. The front plate is set with cut-outs parallel to the existing keyway bottoms. Moving the front plate also sets the inner ring at the inboard end. A milling machine is loaded on to the front ring and inner ring in each of the four positions to machine the keyways. The three-axis milling machine ensures that the keyways are cut to size and are concentric to the shaft and original keyways. The in-situ machining was very accurate and better than machining the hub in a workshop.
