Press Information

METALOCK GIVES ESB TURBINE NEW LEASE OF LIFE

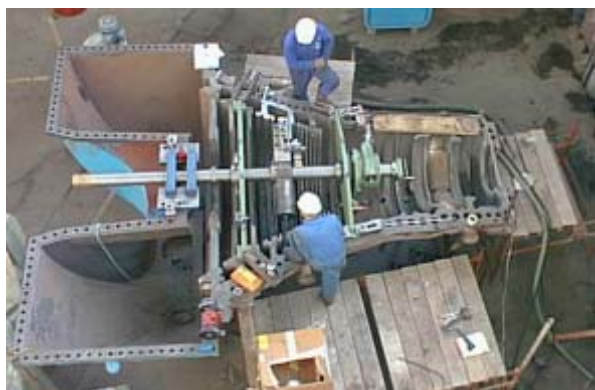
Machining to remove the four rows of blades on the turbine casing cover was done in an adjacent bay by using a cooling system to cut away the centre of the existing caulking pieces without cutting into the serrations.

Metallock and Turbine Blading Ltd evaluated the possibilities of repair and Metallock was subsequently appointed to do the work. This involved removing the affected fixed blades, machining the areas between them to accept semi-circular inserts, and recutting one side of the serrations in line to accept new caulking pieces.

Work to the lower half casing was carried out in-situ in its operating position whilst that on the cover was performed in an adjacent loading bay. To remove the four rows of blades, Metallock engineers devised a tooling system to cut away the centre of the existing caulking pieces without cutting into the serrations of either the blading or the casing. Once a row was completed, the blades in packets of six, were easily removed.
