BAR QUALITY IMPROVEMENTS FOLLOW METALOCK MILL REFURBISHMENT AT LLANWERN

To restore stands R2 and R3 of the roughing mill to their original manufacturing tolerances for squareness, straightness and dimensional accuracy and eliminate risk of cambered bars at Corus Llanwern hot strip mill, Metallock Engineering UK, Coventry in conjunction with the mill management, carried out extensive in-situ machining work during a recent shutdown. Metallock has a wealth of experience in this type of work and has developed equipment and expertise enabling it to undertake such projects effectively.

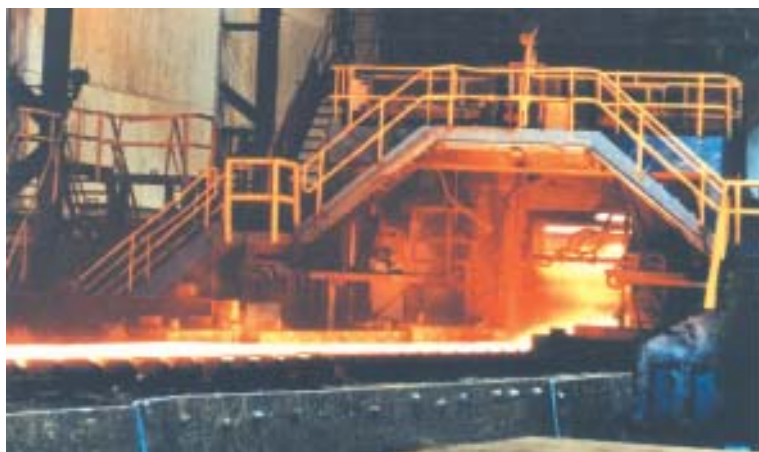
Stands R2 and R3 of the roughing mill at Corus Llanwern's hot strip mill were restored to original tolerances using in-situ machining expertise by Metallock

The project involved machining the vertical wear plate faces (windows) and wrap around edges on R2 and R3 mill housings. The 1.7m wide x 6m high vertical windows and new wrap around edges on each of the four columns required machining to full height. This allowed oversize hardened wear plates to be fitted and original dimensions restored. Additionally, over 200 1¼-inch BSW holes were to be refurbished by drilling and tapping oversize to M48 holes, then fitting screwed inserts with a central 1¼-inch BSW tapped hole.

For the vertical wear plate faces and wrap around edges machining operations, special purpose milling machines, designed and built previously by Metallock, were adapted to suit the larger mill housings at the Llanwern plant. To drill and tap the a large number of M48 holes on the wear plate faces Metallock engineers designed and manufactured two special-purpose drilling machines mounted on 6m long jig plates that covered the full face and facilitated rapid access to every hole.

By using two special purpose milling machines, the operator side windows on both stands were machined concurrently. At the same time, two drilling rigs were used to drill and tap the holes in the drive sides of both stands. On completion of those four operations, the machines were changed over to drill and tap the operator sides and machine both drive side windows. Organizing concurrent operations on each stand this way enabled the project to be completed well within programme and budget.
