METALOCK UK'S LARGEST EVER METALOCK COLD REPAIR PROJECT CONTINUES

In 1985 Metalock Engineering was contacted by British Rail to investigate the feasibility of a cold repair to the cracked cast iron fascia panels on the high level bridge over the River Tyne, a Grade 1 listed structure.

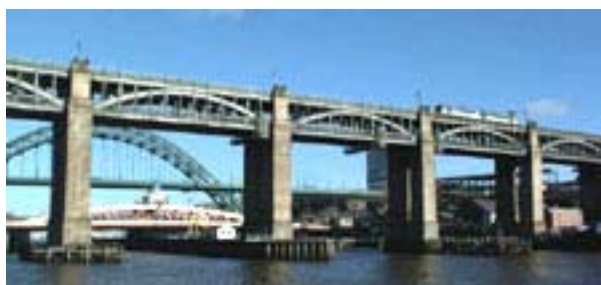
Completed in 1849, the Newcastle High Level bridge is the first major example of a wrought iron tied arch or bow string girder bridge
