## Press Information

### CRACKED FORGING PRESS CROSSHEAD LIVES ON, THANKS TO METALOCK REPAIR

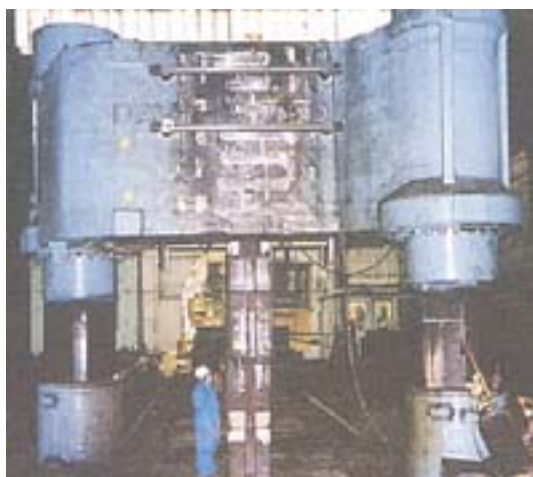
*The Metallock repair was enhanced by fitting tie rods. The repair was so good that the new crosshead was never used*

Metallock Engineering was asked to assist with the new problem and devised a metallock repair followed by regular inspections thereafter. Following an NDT inspection the crosshead was marked out for milling to accept "masterlocks" to restore strength to the crosshead. Seven rectangular masterlocks were used, three of which were double masterlocks to provide increased strength. These were located at strategic points across the fractured component. To save time, Metallock Onsite Machining department engineers used a portable milling machine for the masterlock apertures and once machined the special steel masterlocks were inserted and secured in place with dowels and studs. Finally the surface was peened and dressed.

To enhance the repair it was agreed at the design stage to fit specially made tie rods. Anchors for these extended the full depth of the crosshead and the nuts for the tie rods were secured by locking pins to prevent movement during forging production.
