## **CORUS MAINTAINS AVAILABILITY OF TEEMING LADLES WITH METALOCK INSITU MACHINING REPAIRS**

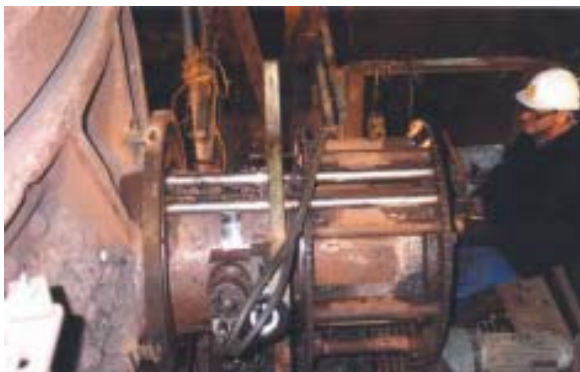
*A specially designed orbital milling device machines the trunion to 510mm diameter prior to finish turning down to 500mm diameter to accept an EN14a shrink-fitted ring.*

Metalock's sequence of operations began by flame cutting the front plate holding the two auxiliary trunnions and air arcing away the welding from both plates. This left the 560mm diameter main trunion and its 406mm diameter spigot clear for machining. A specially designed orbital milling machine was then attached via a fixture to the spigot and the trunion milled to 510mm diameter for its full 356mm length leaving a 22mm radius at the inner corner. The milling device was replaced with a turning tool and the trunion finish turned down to 500mm.

The fixture was then reversed to locate on the newly machined trunion to clean up the spigot diameter by turning, reducing it from 406mm diameter down to 400mm. It was then ready to accept new end plates and auxiliary trunnions. Before these were fitted however, an EN14a ring was shrink fitted on to the 500mm diameter stub and finish turned to 560mm diameter.

Using orbital milling to remove stock from the main trunion saves time and the final turning operation achieves a good finish. The orbital milling machine rotates using a DC motor to provide variable speed, while the milling head is driven by an hydraulic motor.
