### IN-SITU RESTORATION OF PIELSTICK CYLINDER DIMENSIONS ELIMINATES NEED FOR COSTLY ENGINE REPLACEMENT

Metallock Engineering's ability to successfully in-situ machine entablature tops and lower liner landings on a 16-cylinder Pielstick 2 Series marine engine has saved substantial downtime and money at A&P Wallsend-on-Tyne shipyard.

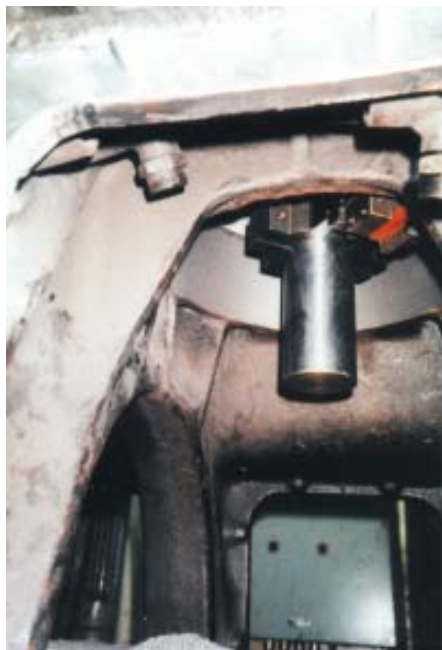
*Metallock designed a machine specially suited to Pielstick engines enabling it to successfully machine entablature tops and lower liner landings on a 16-cylinder 2 Series marine engine.*

Because the main bolts on a Pielstick engine are located inside the top seal face, use of standard equipment for machining the required areas on conventional marine engines was precluded. The water jacket is also removable so to overcome these differences Metallock designed a machine that is specially suited to these engines and which is capable of both refacing the entablature tops and boring out the lower liner landings.

Using this device at Wallsend, Imm was machined off the entablature top, and the lower liner landings bored oversize, leaving a shoulder at the bottom, to accept a precisely machined ring. This ring was shrink fitted into place and needed no further machining, thus restoring the bore's original dimensions to accept a new cylinder liner.

The Metallock facing/boring machine is designed to locate accurately on the machined recess at the top of the entablature and be sufficiently robust to enable boring of the lower liner landing with no additional support other than that provided from the top of the cylinder. The tool is driven by hydraulic motor.
