Press Information

METALLOCK MENDS KING-SIZE CRACK FOR THAMES WATER AND GIVES PIPE NEW LEASE OF LIFE WITHOUT DIG DOWN

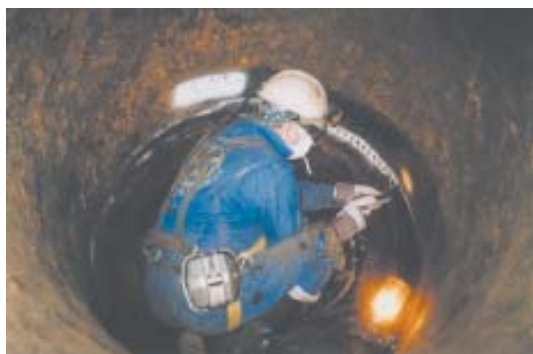
As the Metallock repair process is entirely heat free, it was possible to mend the 48-inch diameter pipe from the inside and produce a rigid and pressure-tight repair.

Basis of the system are the Metallock keys that are fitted and peened into a series of holes jig-drilled across the crack at regular intervals. Holes are then drilled and tapped along the line of the fracture and filled with studs. Each stud is positioned to overlap its neighbour and the combination of keys and studs produce a rigid and pressure-tight repair.
